HCA Asset Management, LLC has performed onsite inspections and valuation services for the **Saratoga Water District**, one of your program's insured entities. We are pleased to submit our restricted appraisal report for certain property of interest to Water & Sewer Risk Management Pool ("WSRMP"), a municipal risk pool operating in the state of Washington.

**HCA Asset Management, LLC**  
**Water & Sewer Risk Management Pool 2020**  
**Location Table**

**HCA Asset Management, LLC**  
**Water & Sewer Risk Management Pool 2020**  
**Insurance Detail Report**

ENTITY: 046 Saratoga Water District  
 SITE: 01 Well House  
 BUILDING: 01 Well House  
 ADDRESS: 3830 RESERVOIR ROAD  
 LANGLEY, WA 98260  
 OCCUPANCY: WELL HOUSE  
 FIRE PROTECTION AND SAFETY: FIRE EXTINGUISHERS

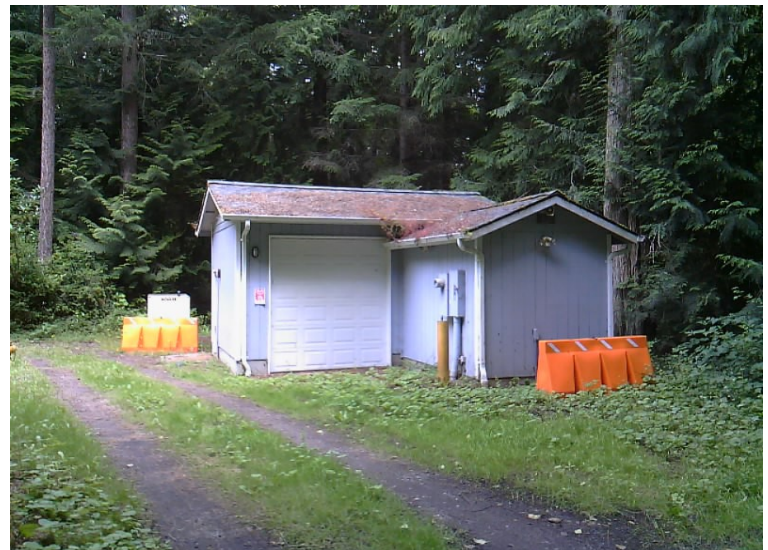
SINGLE STORY WELL HOUSE. BUILDING FEATURES INCLUDE: FILTER ROOM AND WELL HOUSE. PROCESS EQUIPMENT INCLUDES: 12IN DIA WELL CASING (359FT), (2) 15HP SUBMERSIBLE WELL PUMPS, ATEC FILTER SKID, FLOW METER, 2HP COMPRESSOR TANKS, CHLORINE FEED SYSTEM, AND PROCESS PIPING. IN 2010, THE ATEC FILTER SKID WAS INSTALLED.

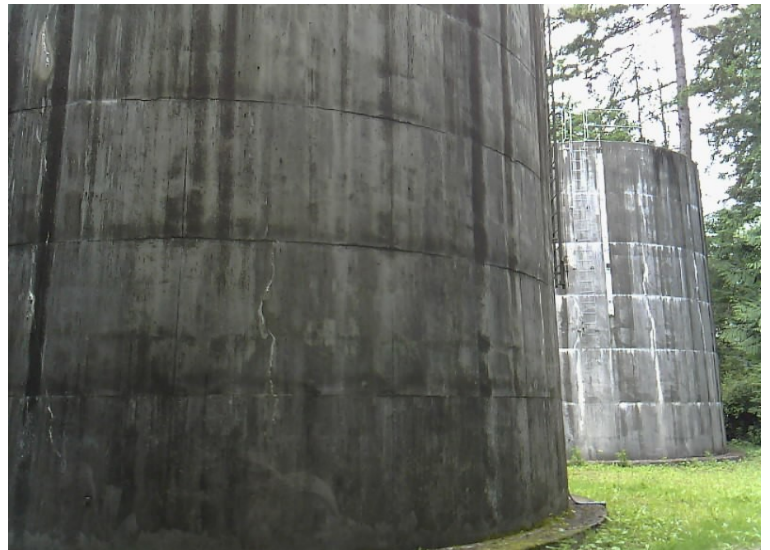
(2) CONCRETE STORAGE TANKS WITH A TOTAL CAPACITY OF 158,000 GALLONS. IN 2015, THE LIDS AND VENTS WERE REPLACED.

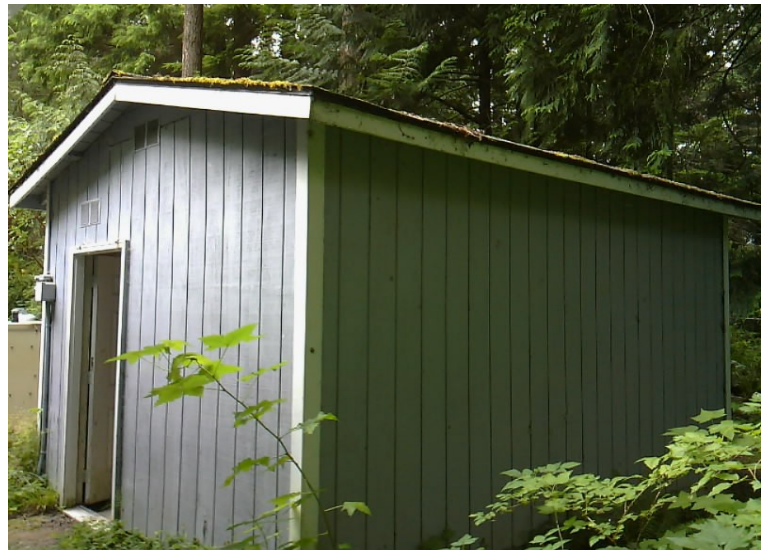
SINGLE STORY PUMP HOUSE. PROCESS EQUIPMENT INCLUDES: (2) 3HP BOOSTER PUMPS, (1) 15HP FIRE PUMP, PRESSURE TANK, TRANSFER SWITCH, CONTROLS, AND PROCESS PIPING.

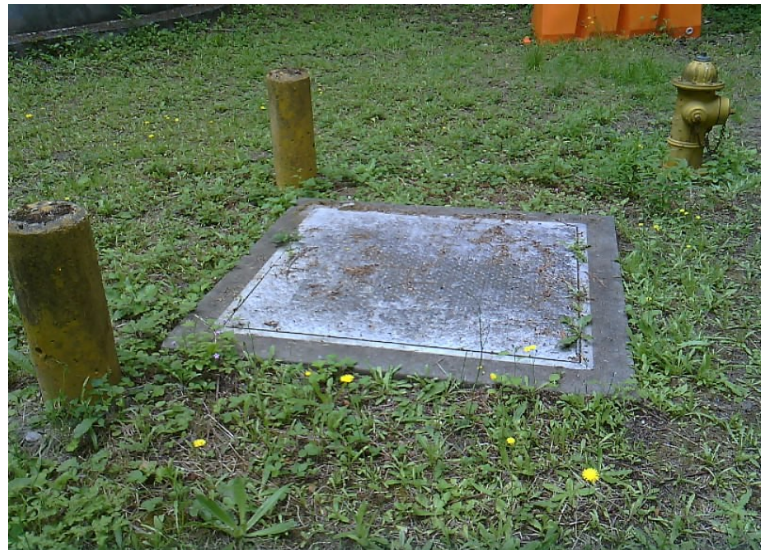
**BUILDING NOTES:**  
 IN-GROUND CONCRETE CONTROL VAULT. PROCESS EQUIPMENT INCLUDES: PROCESS PIPING, VALVES, AND FITTINGS.

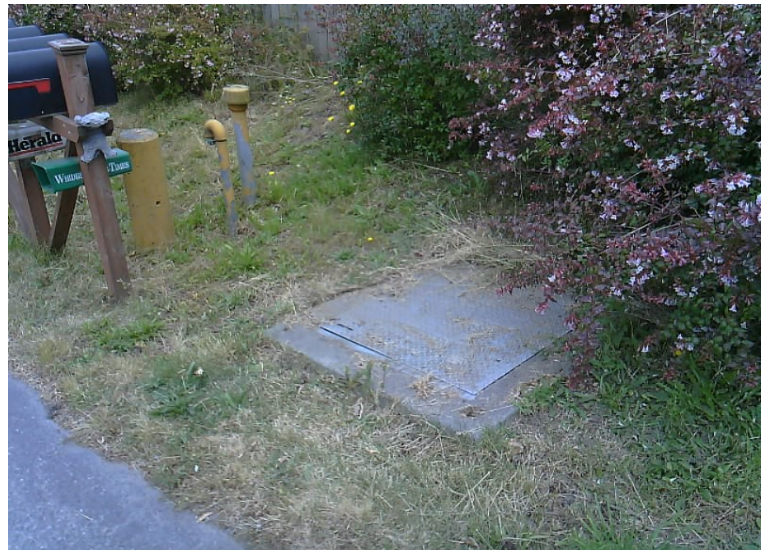
**BUILDING NOTES:**  
 IN-GROUND CONCRETE PRESSURE REDUCING VAULT. PROCESS EQUIPMENT INCLUDES: PROCESS PIPING, VALVES, AND FITTINGS.
